Surface Cracking and Interface Reaction Associated Delamination Failure of Thermal and Environmental Barrier Coatings

1. AGENCY USE ONLY (Leave blank)	2. REPORT DATE April 2003	3. REPORT TYPE AND DATES COVERED Technical Memorandum		
4. TITLE AND SUBTITLE Surface Cracking and Interface Reaction Associated Delamination Failure of Thermal and Environmental Barrier Coatings		5. FUNDING NUMBERS WBS-22-714-04-05 1L161102AF20

9. SPONSORING/MONITORING AGENCY NAME(S) AND ADDRESS(ES) National Aeronautics and Space Administration Washington, DC 20546-0001 and U.S. Army Research Laboratory Adelphi, Maryland 20783-1145		10. SPONSORING/MONITORING AGENCY REPORT NUMBER NASA TM-2003-212318 ARL-TR-2969

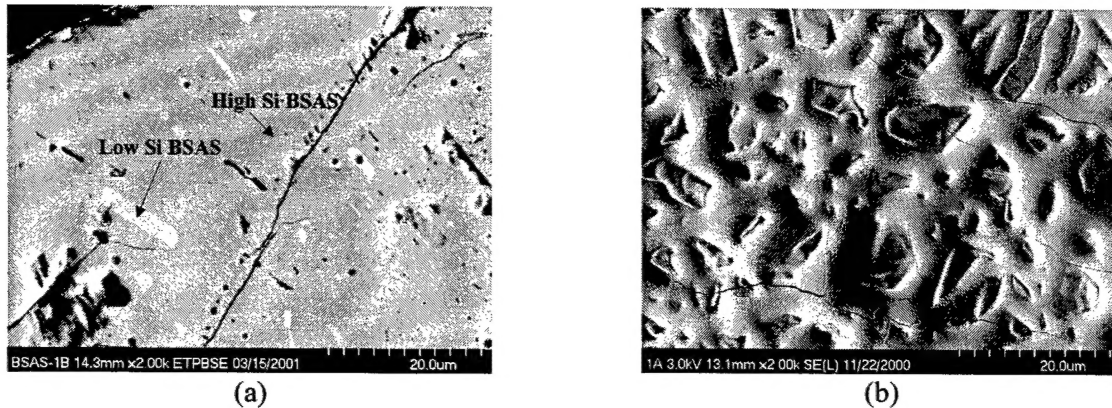
Figure 1.—(a) The BSAS coating was decomposed into low Si (bright second phase) and high Si (dark matrix) phases during initial laser thermal cyclic testing. (b) The higher Si phase became the glass phase and surface cracks were formed after 100 hour cyclic testing at the surface temperature of 1482 °C.

Figure 1 shows SEM microstructures of the BSAS/Si environmental barrier coating after laser thermal gradient cyclic testing. It can be seen from Figure 1 (a) that the BSAS coating was first decomposed and precipitated a lower silicon (Si) containing phase, with the matrix being a high Si containing BSAS. As the coating was further cyclically tested at a surface temperature of $1482\ ^\circ\text{C}$, the BSAS matrix was melted because of the formation of the higher Si and lower melting point BSAS. The surface cracking was also observed after coating melting and glass phase formation.

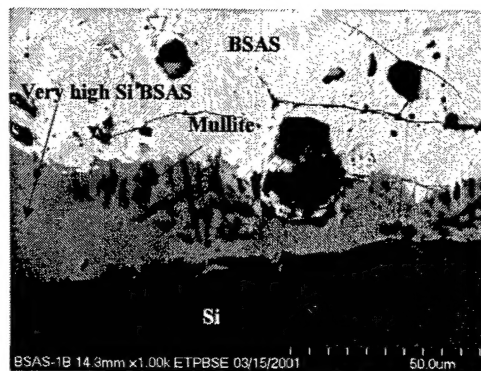
Figure 2.—SEM cross-section micrograph of the BSAS coating after 100 hour laser thermal gradient cycling test. The interface reactions resulted in a dark reaction BSAS layer with high Si concentrations. The mullite phase (very dark needle-shaped phase) precipitation was also found within the high Si reaction BSAS region.

Figure 2 shows a SEM cross-section micrograph of the BSAS coating after 100 hour laser thermal gradient cycling test. The interface reactions between the Si bond coat and BSAS coating resulted in a dark reaction layer with the layer thickness of 30 to 40 microns. The EDS analysis has shown that this BSAS region has very high Si concentrations due to the Si diffusion from the Si bond coat into the BSAS. The high Si concentration BSAS phase was also decomposed into mullite phase (very dark needle-shaped phase) within the high Si BSAS reaction region. Although the coating interface melting was not observed under the 1300 °C interface temperature of the thermal gradient testing for 100 hours, the high Si concentration BSAS reaction layer has been reported to facilitate the coating melting and the glass phase formation under the uniform temperature furnace testing in a water vapor environment at higher temperatures (ref. 5).

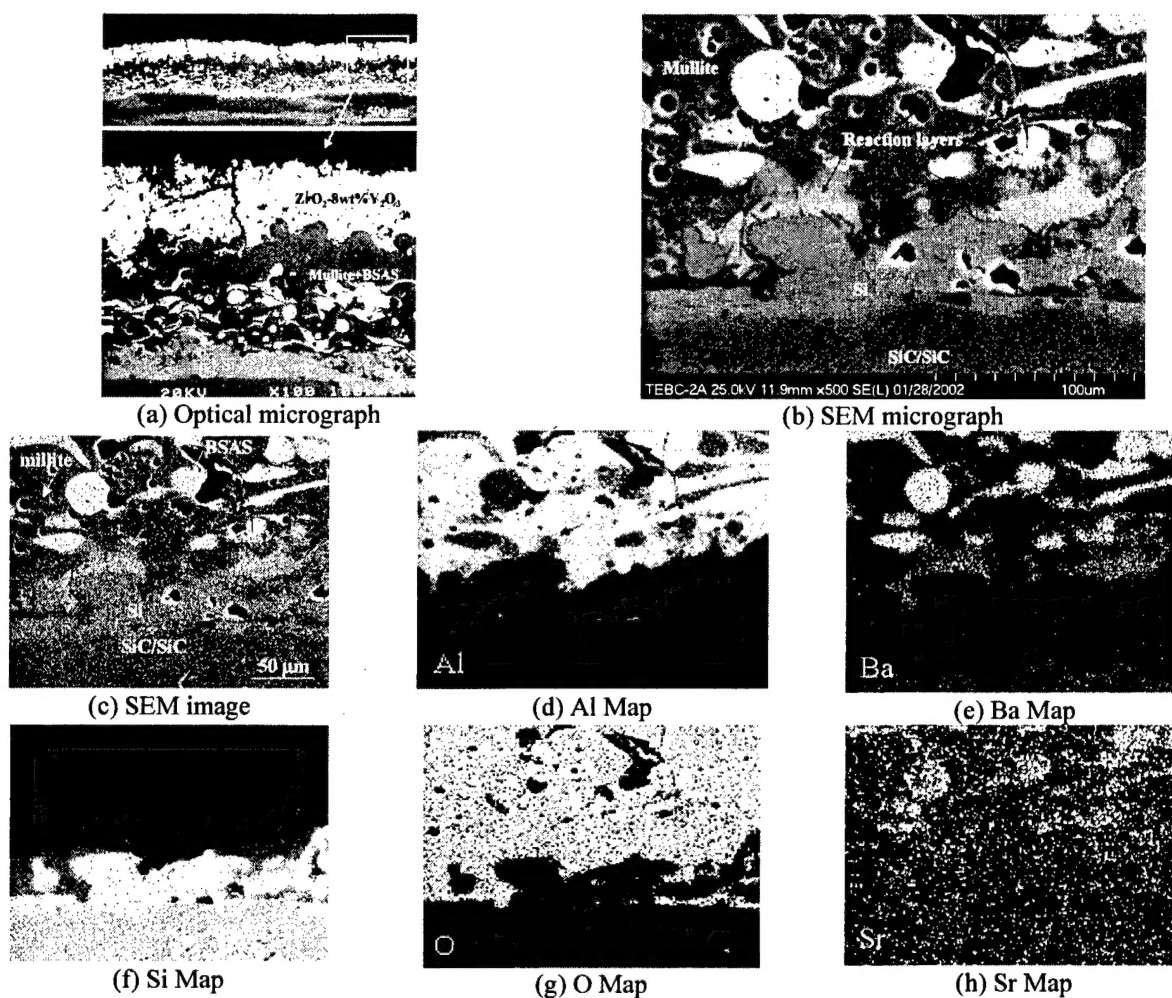
Figure 3.—SEM images and EDS element composition maps of the $ZrO_2-8wt\%Y_2O_3/BSAS+mullite$ mixture/Si on SiC/SiC ceramic matrix composite substrates after laser testing, showing significant interface reactions between BSAS and bond coat Si layer, and the BSAS and mullite. (a) and (b) Optical and SEM micrographs of the coating after 100 hours testing, showing the surface cracking and interface reactions; and (c) to (h) SEM cross-section micrograph and the corresponding EDS elemental maps for the coating systems near the interface.

Figure 3 shows cross-section micrographs and compositional maps of the ZrO_2 -8wt% Y_2O_3 /BSAS+mullite mixture/Si on a SiC/SiC ceramic matrix composite substrate, after 100 hours testing in a combined alternating laser thermal gradient cyclic and furnace water vapor exposure cyclic

testing. It can be seen that substantial thermal gradient induced coating surface wedge-shape cracking has occurred and the resulting delamination was observed for the coating specimen. As shown in Figure 3, significant interface reactions within the mullite+BSAS EBC layer occurred. The reaction affected zone can be as thick as 30 to 40 microns, especially near the interface and the BSAS phase (bright phase) regions. The reactions between mullite and BSAS phases were also noticed with a typical reaction layer thickness of 2 to 5 microns. However, the inter-diffusion of Ba and Al between the mullite and BSAS can occur at a much greater distance, as indicated by the EDS composition maps in Figure 3 (d) and (e). The reactions were further enhanced by the surface crack penetrations into the EBC layer which allowed the water vapor fast access to the coating at the EBC/Si interface. The accelerated coating damage under the thermal gradient cyclic testing combined with the furnace water vapor testing was attributed to the increased delamination driving force under the thermal gradient cyclic loading and the reduced interface adhesion due to the detrimental interface reactions (refs. 4, 6).

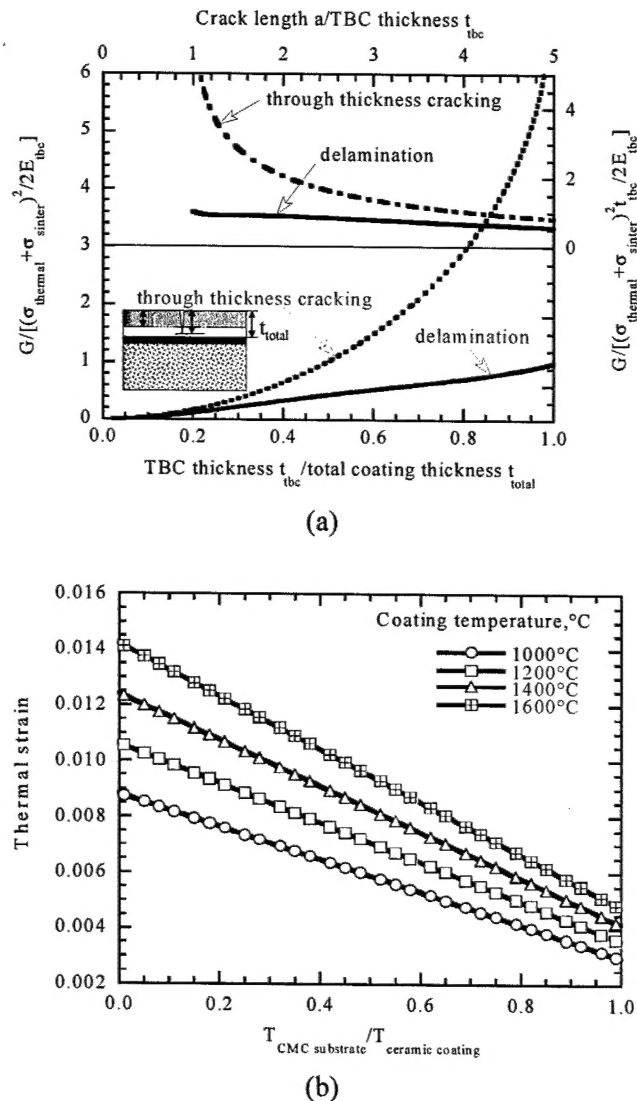
Figure 4.—(a) $\text{ZrO}_2\text{-Y}_2\text{O}_3$ TBC layer on mullite-BSAS EBC and CMC substrates, the coating surface cracking and delamination energy release rates can increase significantly with a relatively thick, and larger thermal expansion $\text{ZrO}_2\text{-Y}_2\text{O}_3$ TBC layer on mullite-BSAS EBC on CMC substrates. (b) The significantly larger thermal stresses/strains will be generated with increasing the thermal gradients (the temperature difference between the ceramic coating and the substrates).

The coating surface cracking is largely due to ceramic top coat sintering and thermal expansion mismatch, especially under the large thermal gradient conditions. As can be seen in Figure 4, with a relatively thick, higher thermal expansion $\text{ZrO}_2\text{-Y}_2\text{O}_3$ TBC layer on mullite-BSAS EBC and CMC substrates, the coating surface cracking and delamination driving force can increase significantly, based on a thermal gradient testing delamination model proposed in the literature (ref. 7). The significantly larger thermal stresses generated under thermal gradients will also accelerate the coating delamination under the thermal cyclic conditions.

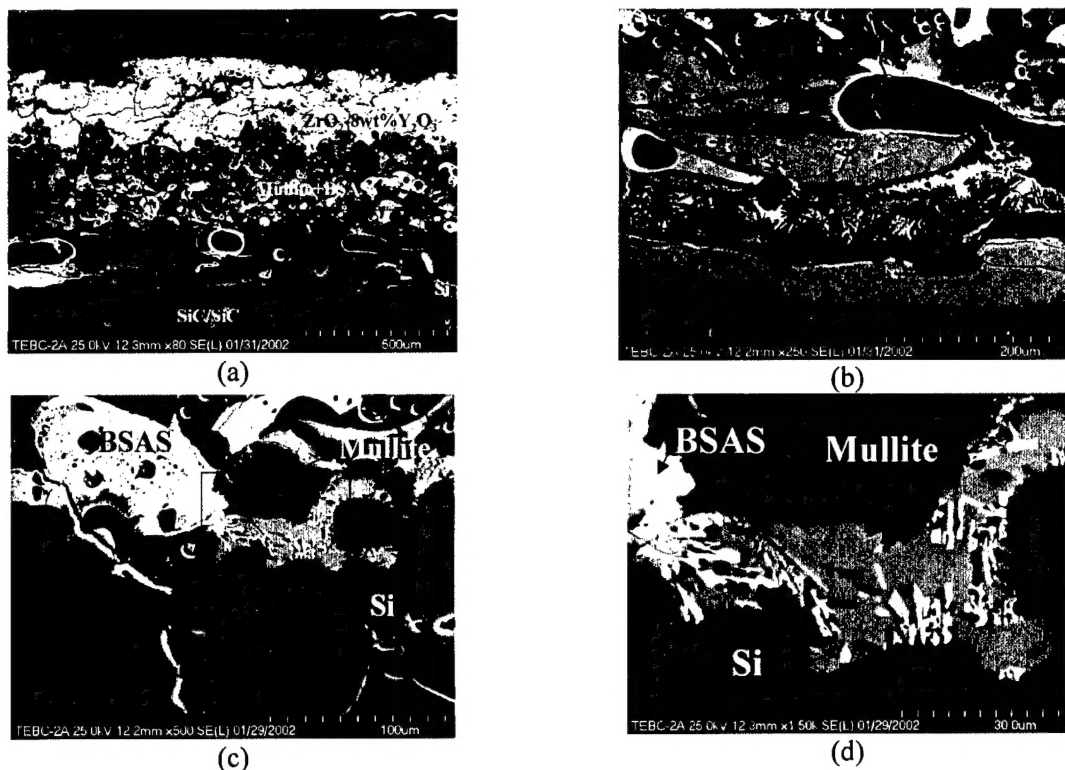
Figure 5.—SEM cross-section micrographs of the $\text{ZrO}_2\text{-8wt\%Y}_2\text{O}_3\text{/BSAS+mullite mixture/Si}$ on a SiC/SiC ceramic matrix composite substrate, after total 400 hours testing in the combined laser thermal gradient and furnace water vapor cyclic testing. (a) Significant interfacial pore formation due to the water vapor attack through the vertical cracks under the thermal gradient cycling conditions. (b) Low melting eutectic phase was also observed near the BSAS-mullite-Si interfaces after the testing.

Figure 5 shows the SEM cross-section micrographs of the $\text{ZrO}_2\text{-8wt\%Y}_2\text{O}_3\text{/BSAS+mullite mixture/Si}$ on a SiC/SiC ceramic matrix composite substrate, after 400 hours of testing in the combined laser thermal gradient and furnace water vapor cyclic testing. Extensive coating delamination and some spallation were observed during the testing. From Figure 5 (a) and (b), it can be seen that, in addition to the more significant reactions between the EBC mullite, BSAS and Si bond coat, large interfacial pores developed due to the water vapor attack through the vertical cracks in the EBC coatings. From Figure 5 (c) and (d), it can also be seen that a low melting point eutectic phase around the BSAS, Si, and mullite interfaces formed. For the top $\text{ZrO}_2\text{-Y}_2\text{O}_3$ coating side, no obvious reactions were found between mullite and $\text{ZrO}_2\text{-8wt\%Y}_2\text{O}_3$ coatings after the 400 hours combined laser and furnace water vapor thermal cycling test.
